An unusual case of implantable cardioverter-defibrillator inhibition

Clinical record

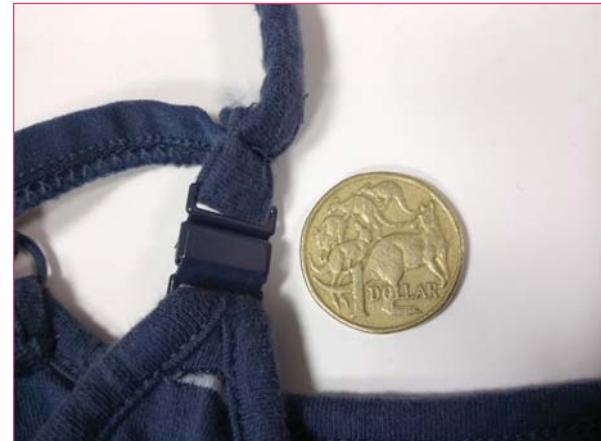
The magnetic clip on the patient's maternity bra (size comparison with an Australian \$1 coin).

On close examination of the bra, we noted a small magnetic clip (about 1cm x 1cm) located on each side of the anterior-facing straps, for ease of breastfeeding (Figure). When the patient wore the bra, one clip was located directly over the ICD in the left subclavicular region and did not vary when she moved. As the magnetic clip was positioned over the ICD, the alarm sounded. The alarm ceased when the clip was moved from this position.

Magnetic fields of >10 gauss appear to be sufficient to inhibit the device.⁴ Our tests showed that the magnet in question exhibited field strengths of up to 800 gauss (Appendix 1, Appendix 2).

The patient avoided using this bra again, and no further episodes of alarm activation were noted. ♦

manufacturer and Medtronic have been alerted to the potential hazard of permanent electromagnetic interference from such a magnetic clip. Discussion is underway regarding the addition of warning labels to their products.
